PRODUCT IMPROVEMENT TEST OF

MODIFIED AR15 RIFLES

REPORT NO. DPS-1276

DEVELOPMENT AND PROOF SERVICES
REPORT ON USATECOM PROJECT NO. 8-3-0030-08-F,
PRODUCT IMPROVEMENT TEST OF
MODIFIED AR15 RIFLES
12 NOVEMBER TO 5 DECEMBER 1963

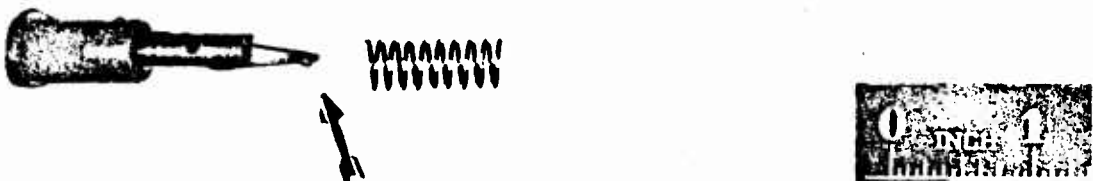
- a. The size of the plunger cap of the bolt closure device was increased. Figures 2 and 3 show the first and second designs of this device. The second design incorporated a stronger plunger spring and the pawl tip was straight instead of beveled. The pawl hardness was increased from Rockwell C 43 to C 51 at the tip.
- b. Modification of the charging handle (Figure 4) was made by enlarging the grip area so manual retraction of the bolt and carrier assemblies is easier.

Figure 2: Modified Charging Handle and Bolt Closing Devices for the AR15 Rifle.

- a. The frequency of feeding and chambering malfunctions indicates the necessity of a positive method of manually assisting the forward movement of the bolt and bolt carrier assemblies. The bolt closure device with 1.30-inch-long plunger spring and pawl with straight tip, hardened to Rockwell C 53, was adequate in performing its intended function (ref Figures 3 and 8 and Tables IV, V, and XV).
